**Flood Control Project Maintenance
Levee Inspections**
LMA District Cover Sheet
Spring 2013 Levee Inspection Results

Reclamation District No. 2060 Hastings

Levee Inspection Report By Mile - Spring 2013

Waterway				Bank	Unit Miles	Inspection Start/End	Inspector
Unit No. 01 Lindsey Slough				Left	6.94	03/28/2013 03/28/2013	Herman Phillips

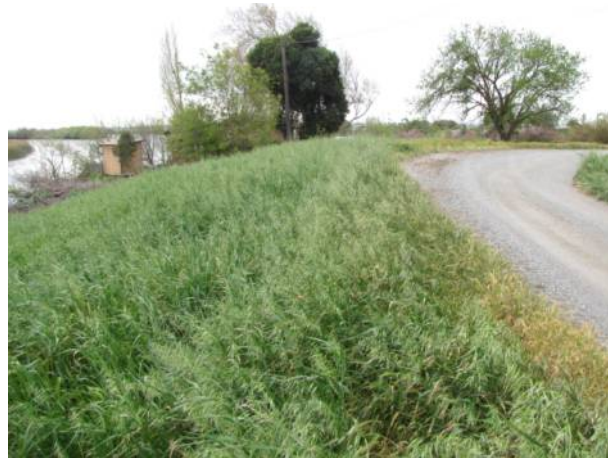
Levee Mile Report Line	4
Start Levee Mile	0.00
End Levee Mile	0.00
Location	Water Side
Category	
Item	Vegetation
RD 2060 Looking downstream from levee mile 0.00. Photo taken 3-28-2013.	
phillips_s_20130403_361.JPG

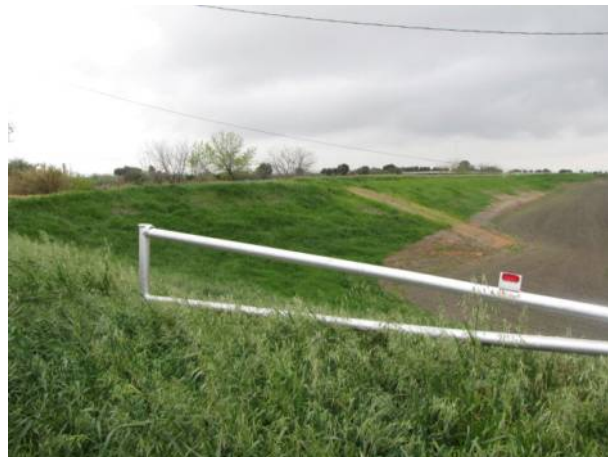
Levee Mile Report Line	6
Start Levee Mile	0.00
End Levee Mile	0.00
Location	Land Side
Category	
Item	Vegetation
RD 2060 Looking downstream from the landside slope from levee mile 0.00. Photo taken 3-28-2013.	
phillips_s_20130403_362.JPG

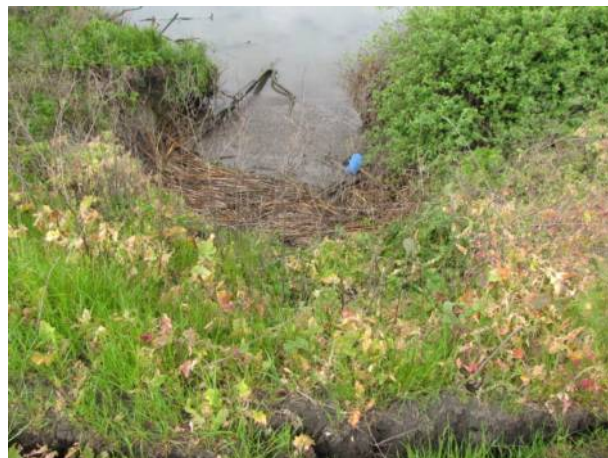
Ma				
DWR ID: DWR_RD2060_01_s_2013_7										
10	1.90	1.90		Erosion / Bank Caving	WS	M	E1 : Note and monitor erosion site. Inspector Comments: District has plans to bring material to be placed at site along with more rock, stated during the inspection 3-28-2013.	38.256664 ° -121.721535 °	38.256664 ° -121.721535 °	9 Y
						Ma				
DWR ID: DWR_RD2060_01_s_2013_9										
11	1.91	1.91		Erosion / Bank Caving	WS	M	E2 : Schedule repair of erosion site prior to the next inspection. Inspector Comments: It appears that this site is also active. Spring inspection 2013.	38.256664 ° -121.724536 °	38.256664 ° -121.724536 °	13 Y
						Ma				
DWR ID: DWR_RD2060_01_s_2013_13

Levee Mile Report Line	10
Start Levee Mile	1.90
End Levee Mile	1.90
Location	Water Side
Category	
Item	Erosion / Bank Caving
RD 2060 Levee mile 1.90 erosion site (active). Photo taken 3-28-2013.	
phillips_s_20130403_358.JPG

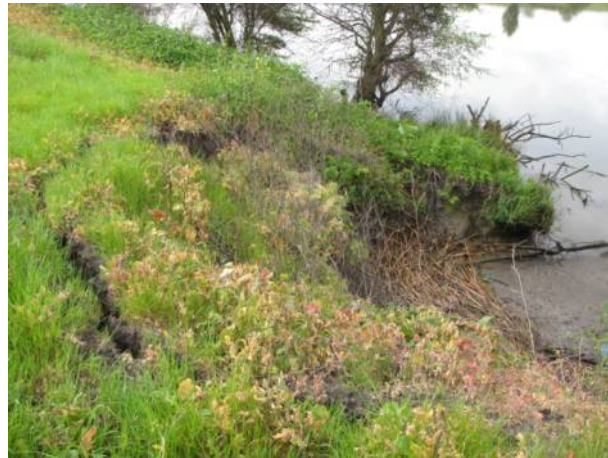
Levee Mile Report Line	10
Start Levee Mile	1.90
End Levee Mile	1.90
Location	Water Side
Category	
Item	Erosion / Bank Caving

RD 2060 Levee mile 1.90 this site is active. This shot was taken standing downstream of erosion site. Taken 3-28-2013.

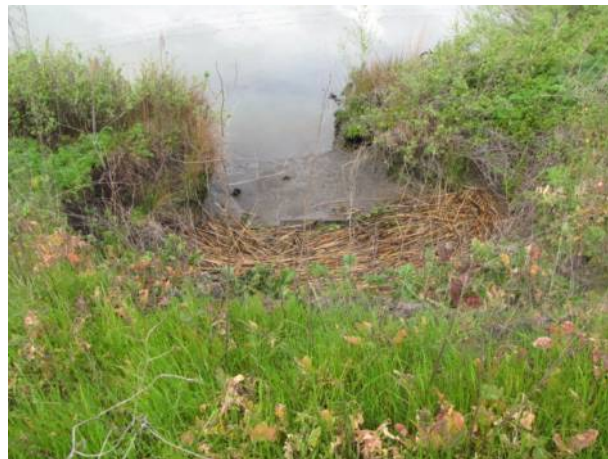
Levee Mile Report Line	11
Start Levee Mile	1.91
End Levee Mile	1.91
Location	Water Side
Category	
Item	Erosion / Bank Caving

RD 2060 Unit 1 levee mile 1.91. This erosion site is active. Photo taken 3-28-2013.

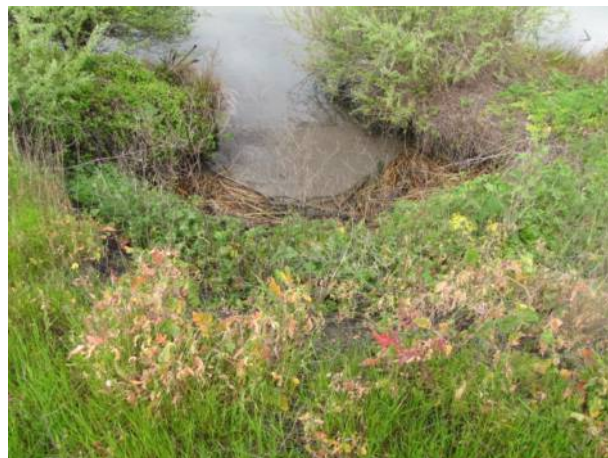
Levee Mile Report Line	12
Start Levee Mile	1.92
End Levee Mile	1.92
Location	Water Side
Category	
Item	Erosion / Bank Caving

LMR No.	Levee Mile		Category	Item	Location *	Rating **	Action/Comment	GPS Latitude/Longitude		Issue No. Photo
	Start	End						Start	End	
12	1.92	1.92		Erosion / Bank Caving	WS	M Ma	E1 : Note and monitor erosion site. Inspector Comments: At this location the material is soft and this site is much like the one at L/M 1.90 AND L/M 1.91. District is aware of the sites and repairs are being planned.	38.256766 ° -121.724552 °	38.256766 ° -121.724552 °	16 Y
DWR ID: DWR_RD2060_01_s_2013_16										
13	2.40	2.40		Erosion / Bank Caving	WS	M Ma	E2 : Schedule repair of erosion site prior to the next inspection.	38.259254 ° -121.727257 °	38.259254 ° -121.727257 °	17
DWR ID: DWR_RD2060_01_s_2013_17										
14	2.44	2.44	Supplemental	USACE Erosion Survey	WS	M Ma	Inspector Comments: 2011 - Two erosion pockets from rotational failures. Very soft soil. 2012: Site is part of the extended inventory, last inspected 2011. [2012 Site ID: LDS_2-4_L]	38.257319 ° -121.732423 °	38.257224 ° -121.731953 °	5

RD 2060 Erosion at levee mile 1.92 Photo taken 3-28-2013.

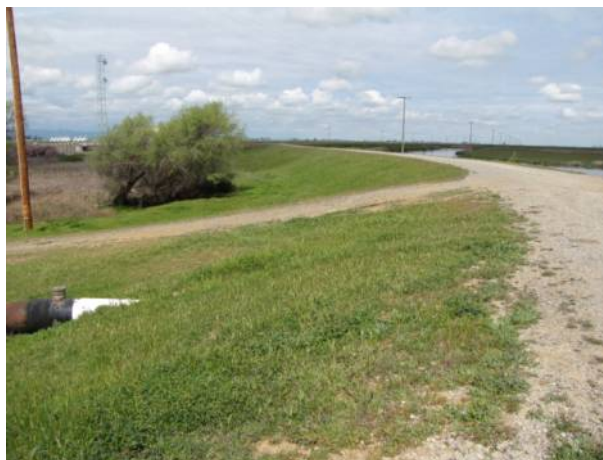
Levee Mile Report Line	1
Start Levee Mile	0.00
End Levee Mile	0.00
Location	Land Side
Category	
Item	Vegetation
RD 2060 Unit 2 looking downstream from levee mile 0.00 landside. Photo taken 3-28-2013.	
phillips_s_20130403_364.JPG

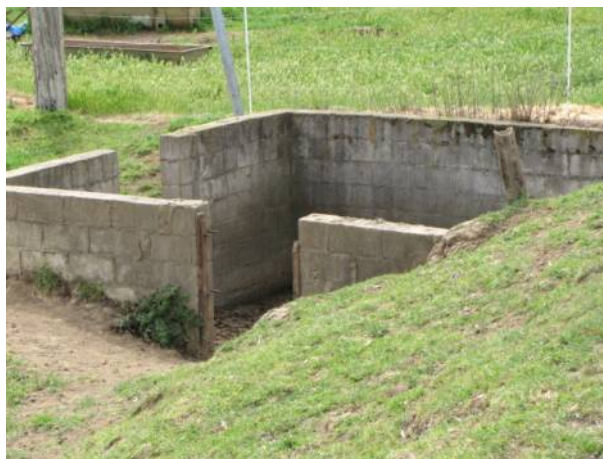
Levee Mile Report Line	4
Start Levee Mile	2.10
End Levee Mile	2.10
Location	Land Side
Category	
Item	Encroachments
This old block structure not in use was placed within the levee section. Photo taken 3-28-2013.	
phillips_s_20130604_476.JPG

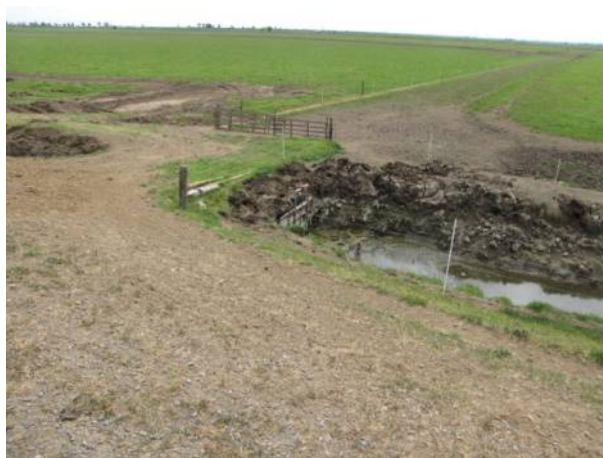
Levee Mile Report Line	6
Start Levee Mile	2.26
End Levee Mile	2.26
Location	Land Side
Category	
Item	Encroachments
This ditch encroaches within the 10-foot easement. Photo taken 3-28-2013.	
phillips_s_20130604_477.JPG

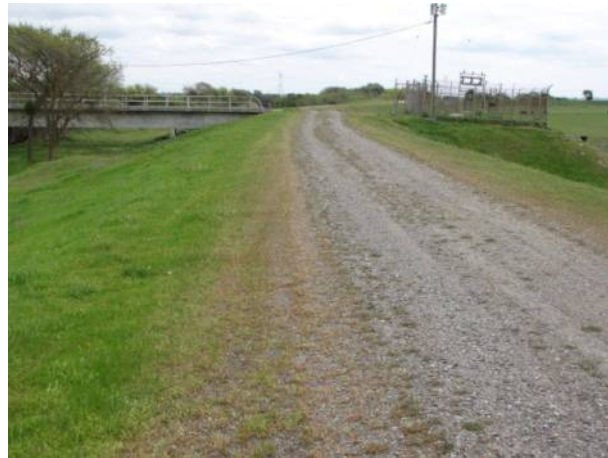
Levee Mile Report Line	1
Start Levee Mile	
End Levee Mile	
Location	Land Side
Category	
Item	Vegetation
Unit 3 RD 2060 looking downstream from levee mile 0.00. Photo taken 3-28-2013.	
phillips_s_20130604_478.JPG

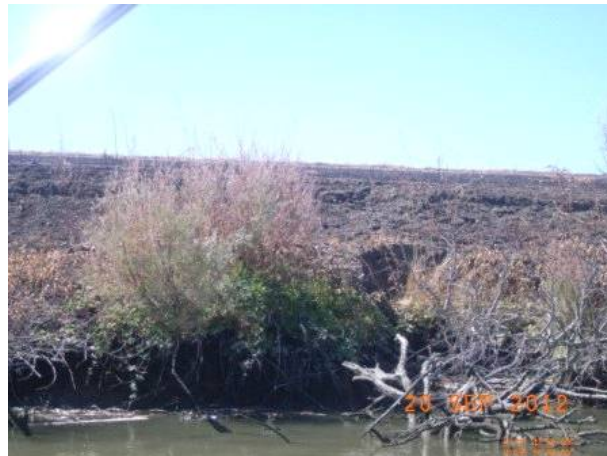
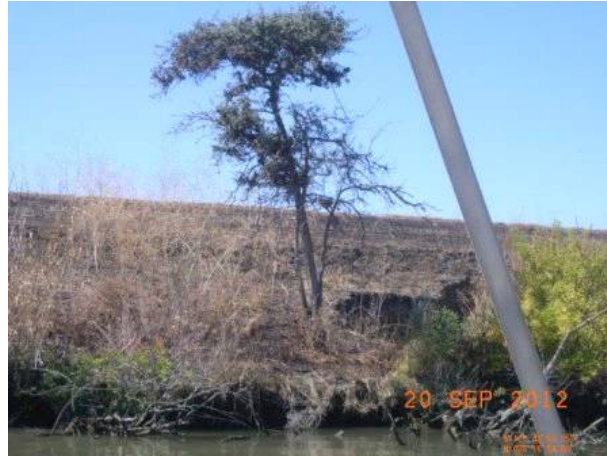
Levee Mile Report Line	4
Start Levee Mile	2.18
End Levee Mile	2.23
Location	Water Side
Category	Supplemental
Item	USACE Erosion Survey

4	2.18	2.23	Supplemental	USACE Erosion Survey	WS Ma	Inspector Comments: 2007 - Geotechnical failure of midside slope and wave wash/scalloping in toe area. Stone revetment upstream and downstream of site. Similar sites are present all along the right bank downstream of this site, most could be repaired with some maintenance. 2010 - Minor new erosion. 2012: No observed change. [2012 Site ID: CHS_22-8_R]	38.282100 ° -121.716817 °	38.281510 ° -121.716319 °	6 Y
DWR ID: DWR_RD2060_03_s_2013_6									
5	2.38	2.54	Supplemental	USACE Erosion Survey	WS Ma	Inspector Comments: 2008 - Small scour pockets and mid-slope wave wash. 2010 - More vegetation growth, could be fixed through maintenance. 2011 - Site extended downstream and new erosion. 2012: No observed change. [2012 Site ID: CHS_22-6_R]	38.280377 ° -121.714633 °	38.278306 ° -121.712722 °	8 Y
DWR ID: DWR_RD2060_03_s_2013_8									
6	2.79	3.25		Vegetation	WSA/W Ob	V8 : Environmental Requirements.	38.280919 ° -121.715756 °	38.275177 ° -121.709777 °	3
